**NEW EXPERT TESTIMONY
TO BE CONSIDERED BY THE OAH
FOR THE INSTANT RECORD
2019-DCRA-00135**

PERSONAL AFFIDAVIT

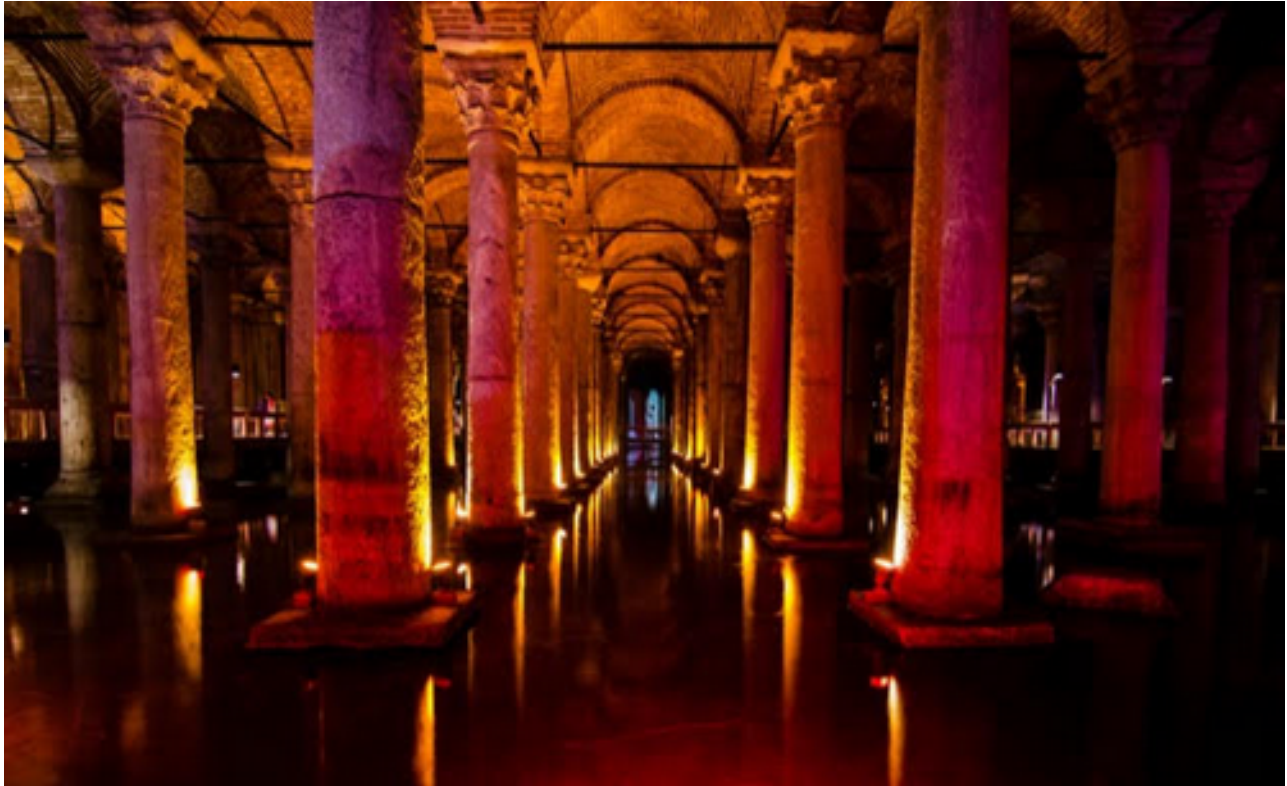
Basilica Cistern in Istanbul with tie-rods at top of columns

7. The Istanbul cisterns have had their cracks repaired. All columns have been wired with steel rings and steel tie-rods to strengthen them in place without interruption of the overall cistern space. "[A]ll 32 columns were strengthened by steel ring to avoid any further damages, and steel tie rods are placed to give a structural support to the cistern. ...Missing parts of the domes are completed with similar but distinguishable materials. The missing bricks on the wall are completed again with similar material but 5cm inside to indicate that they are added later. Cracks on the walls are filled with hydraulic lime mortar and the capillary cracks in the marble columns are filled by epoxy injection. All these interventions are totally visible on purpose to give visitors the feeling of discovering the layers." - Architect Magazine, April 25, 2019, <https://www.architectmagazine.com/project-gallery/theodosius-cistern-restoration>

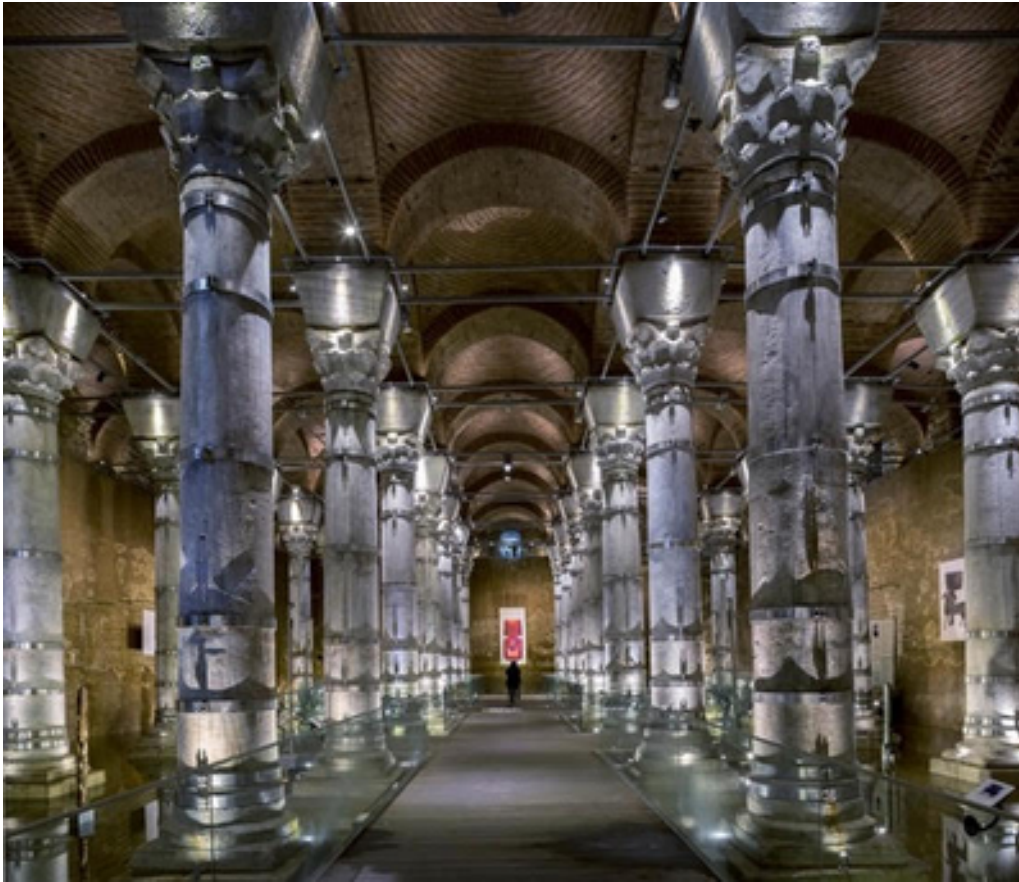
Theodosius cistern in Istanbul with steel reinforcing rings

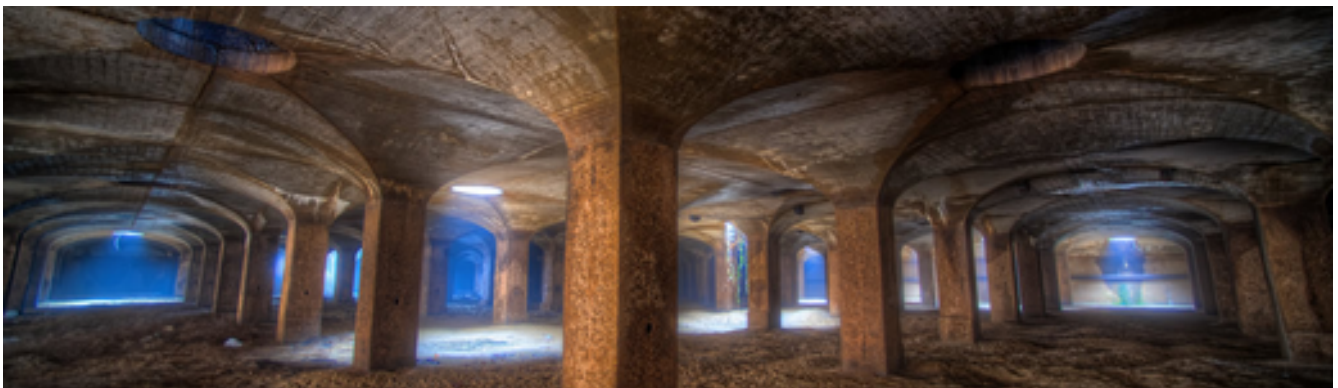
McMillan Park Underground Water Cells

8. Just like the Istanbul cisterns, undeniably and as expected by city planners in 2002, DC can preserve and protect the stable and semi-stable vaults and columns at McMillan Park. In fact, the city set a price of restoration of about \$2M per cell. This would ensure compliance with the Historic Preservation Covenants that are attached to the McMillan Park deed and would thus ensure conformance of any project at the site with the Secretary of the Interior Standards as to treatment of historic sites like McMillan Park.
